CATHODIC PROTECTION CONFERENCE

Cathodic Misconceptions

C.G. Googan

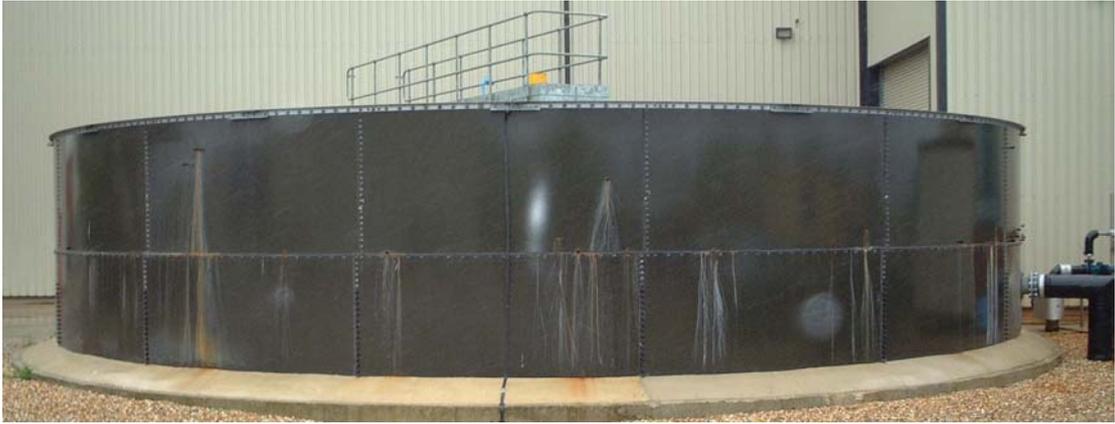
Figure 1 Effluent Water Treatment Tank

Figure 1 shows a painted steel effluent water treatment tank at a meat processing factory. The tank contained an internal weir structure fabricated in stainless steel (Figure 2). The water had a high conductivity and was well aerated (as indicated by the growth of algae). This design led to a classic case of galvanic corrosion, with a large cathode (the stainless steel weir) coupled to a small area of anode (the areas of damaged paint on the tank wall). Localized penetration of the tank soon occurred.

The owner sought advice from the tank manufacturer, and was informed (quite correctly) that the problem could be remedied by the installation of sacrificial anodes. A request to procure anodes was then passed over to the accountant who saved money by dispensing with the cost of involving a CP design engineer. Instead he ordered four “suitable” anodes from a yacht chandler. These were installed by the company’s own maintenance fitters. Sadly, however, there was no discernable reduction in the frequency of leaks (Figure 3).

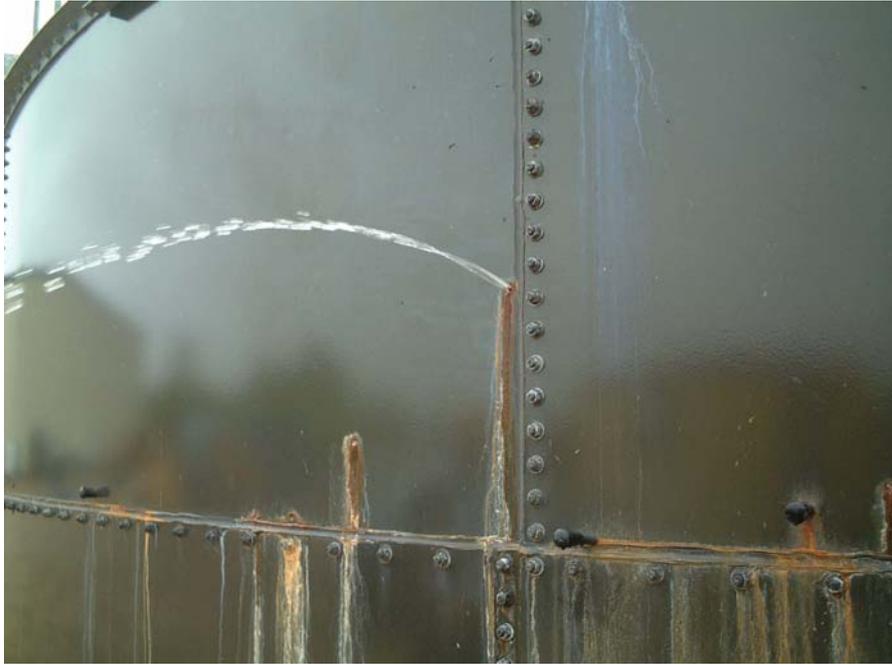
Figure 3 Result of Inadequate Internal CP

This author’s subsequent potential measurements confirmed that the undersized anodes were failing to exert any useful effect on the galvanic corrosion.

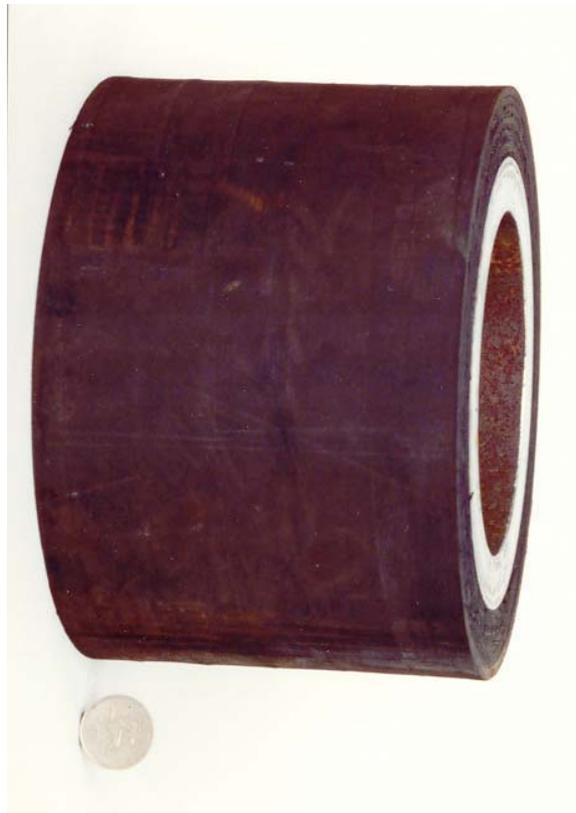
Figure 4 Section of 6-inch nb flowline with 25 mm EPDM rubber coating

Figure 4 shows a section of 6-inch EPDM rubber coated flowline installed in the North Sea some fifteen years ago. The CP was provided by sacrificial anode bracelets which had been designed according to the accepted guidelines of the day. However, a survey carried out two years after installation showed that, despite the anodes yielding more than the design current, the line had failed to polarize to its protection potential.

Subsequent investigations revealed that the cause of the problem was the carbon black used as a filler in the rubber coating. Laboratory measurements showed that, although the polymer itself was expected to have a specific electrical resistivity of $10^{14} \Omega\text{m}$, the value for the carbon-loaded coating was $10 \Omega\text{m}$ at atmospheric pressure, falling to $2 \Omega\text{m}$ at 16 bar (the water pressure at the installation depth). What is more, as expected from the galvanic series, the carbon was acting as a cathode: draining current from the anodes and potentially putting the pipeline at risk.

Even before the cause of the problem could be fully elucidated it was clear that there was a need to install additional CP. This necessitated a costly retrofit using the (then) innovative approach of magnesium anode arrays connected to the pipeline via voltage limiting diodes^[11].

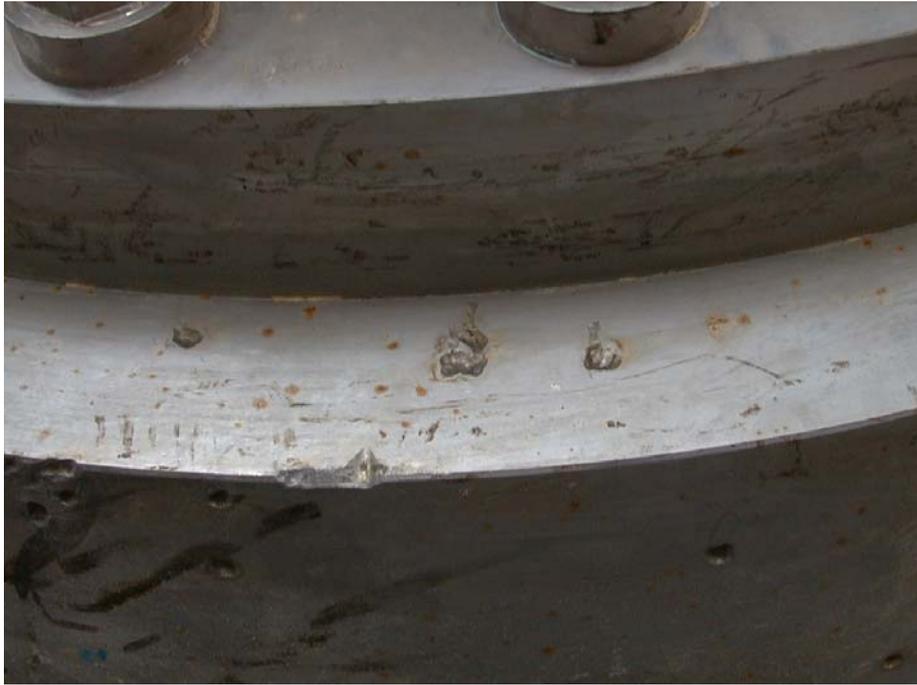
Figure 5 Pitting damage to a stainless steel propeller hub – fast ferry newbuilding

In the case of a fast ferry constructed in 2001, however, the propellers were made in austenitic stainless steel (UNS S31600); a material selected because of its superior mechanical characteristics. Quite correctly, the vessel's designers had recognized that that particular grade of stainless steel does not possess adequate inherent corrosion resistance for seawater service. Accordingly, the design included a slip-ring device bonding the propeller into the hull's impressed current system.

However, what the designers either failed to appreciate, or else failed to communicate to the builders, was that the stainless steel was at risk during the period between launch and the commissioning of the CP. In the event, the vessel lay afloat with the CP system inactive during the four month fitting out period. Unfortunately, although this period was relatively short in shipbuilding terms, it was sufficient for pitting corrosion to initiate on the propeller hubs (Figure 5). This caused a delay in the delivery of the vessel, and an acrimonious dispute between the shipyard and the buyer.

The lesson was learned in time for the launch of the sister ship, for which temporary sacrificial anodes were provided to protect the propeller during outfitting (Figure 6).

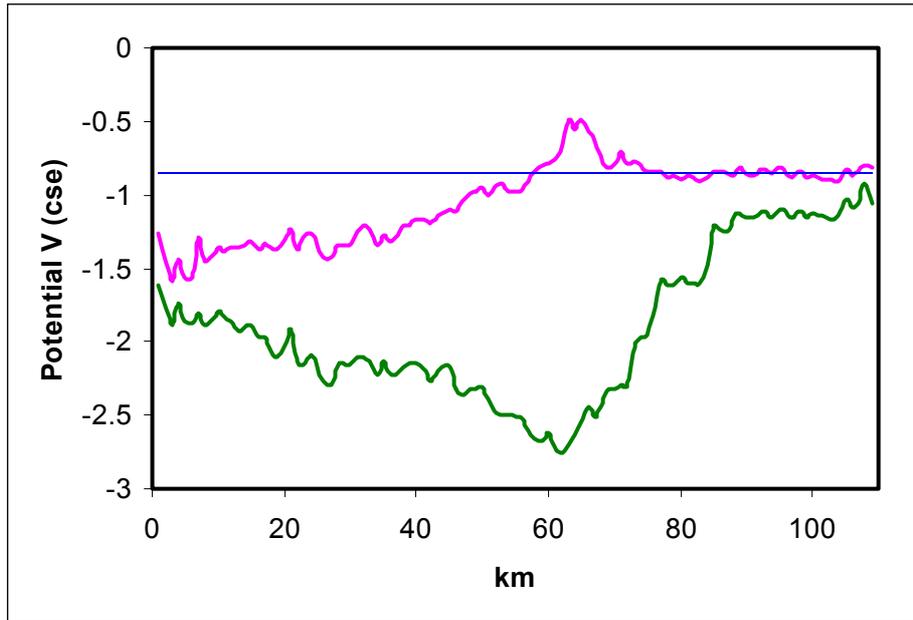
Figure 7 Potential distribution along a high pressure gas transmission line

Figure 7 shows the results of a close interval potential survey (CIPS) along a high pressure gas pipeline. In the original survey the data were collected at 1 m intervals and plotted on sheets each showing 500 m of line. In Figure 7, however, the data for each kilometre have been averaged so that the condition of the entire 112 km of the pipeline can be seen in a single plot.

Prior to the CIPS, the operator had only ever measured on-potentials at test posts 5 km apart; and was of the opinion that the line was well protected. It was only when the CIPS was carried out, and the on-potentials (green line in Figure 7) compared with the off-potentials (purple line) did it become apparent that the line was suffering a dangerous stray current interference problem. (This is revealed by the off-potentials in the region of km 60).

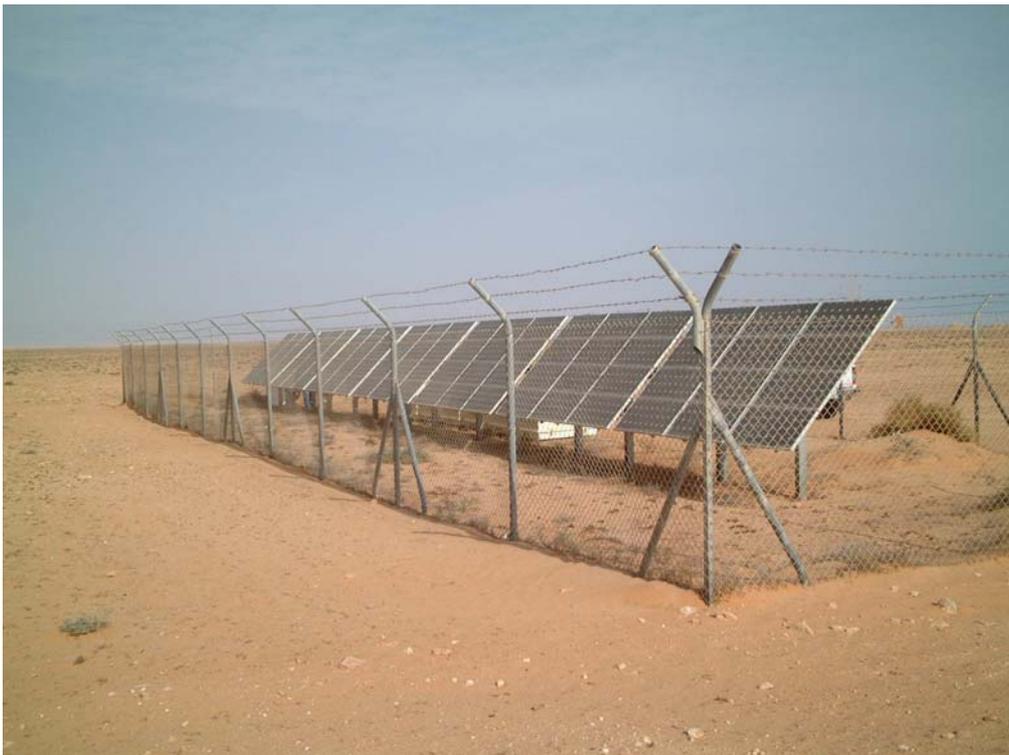
Figure 8 Solar Panel Array

Solar power units of the type illustrated in Figure 8 provide a convenient source of electrical power for CP systems in remote

desert locations. However, it is not always appreciated that the function of the solar panels is not only to provide the CP current but, more important, to charge the batteries (Figure 9).

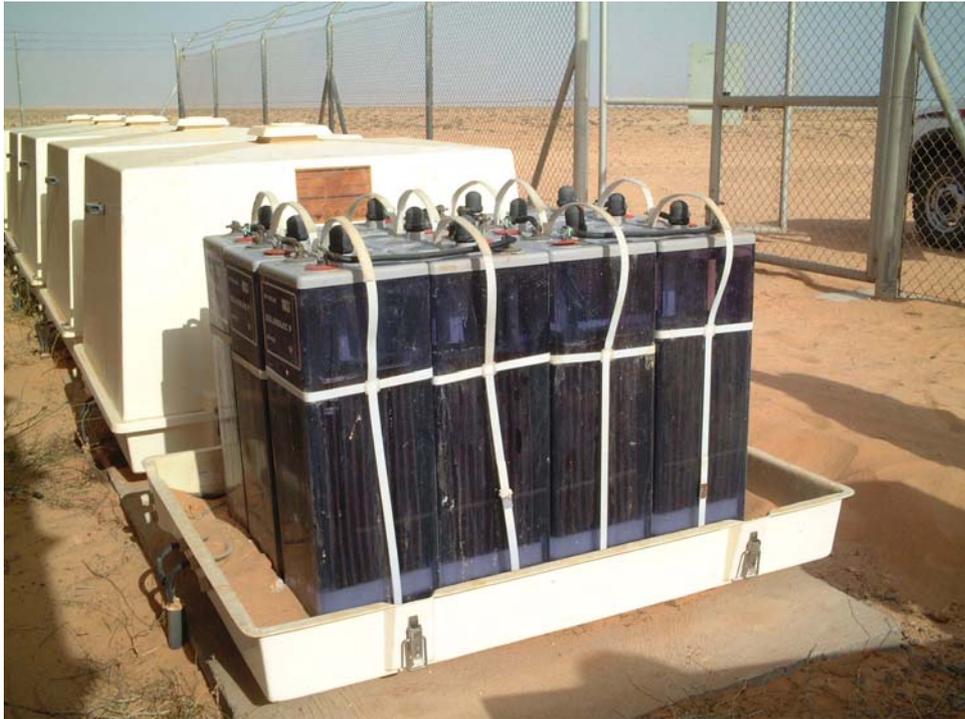
Figure 9 Storage batteries

Unfortunately, the remote locations of these CP stations mean that it is all too easy for routine maintenance, including the topping up of battery electrolyte, to be overlooked.

In one case involving a solar powered CP system for an oil trunk line, it appears that the batteries had never been topped up. Inevitably, they eventually became completely dry. However, the problem went unnoticed for a long time; possibly several years. This was because the (infrequent) CP inspections were only carried out in the day-time, when the solar units were delivering current. Moreover, the inspectors only recorded on-potentials, which gave an unrealistically optimistic indication of the level of protection.

It was only when the author's company audited the CP monitoring and inspection records that the problem came to light. Subsequent monitoring of on- and off-potentials using a data logger over a 24-hour cycle revealed under-protection, and confirmed that the sun does not shine at night!
