# Fellow's Corner

## Galvanic Corrosion – Getting the Message Across

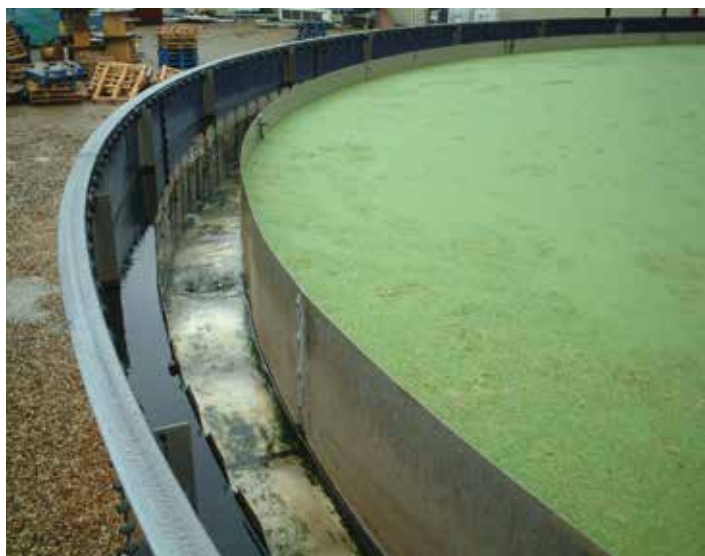
Figure 1.

The first case was a waste-water treatment tank at a UK poultry processing facility. As can be seen in Figure 1, this included stainless steel processing equipment which was electrically earthed to the tank. The effluent treated was warm, intentionally aerated and, being relatively chloride-rich, was highly conducting. The tank supplier recognised this as a galvanic corrosion situation, and that it was made all the more damaging by the very high ratio of the stainless steel area to that of carbon steel at lining defects. Accordingly, the supplier warned the owners of the problem, whilst at the same time prudently withdrawing its warranty.

In response, the owners declined to invest in corrosion expertise. Guided by their accountant, they elected to remedy the situation by cathodic protection (CP), a plausible but, in this case, optimistic approach. Dispensing with the cost of any CP evaluation or design, some small anodes were procured. It is, however, by no means clear how, or indeed if, these anodes were actually installed. In any event, the outcome was all too predictable. Within a matter of weeks, the tank was leaking like a sieve (Figure 2), its role having changed from effluent treatment to effluent dispersal!

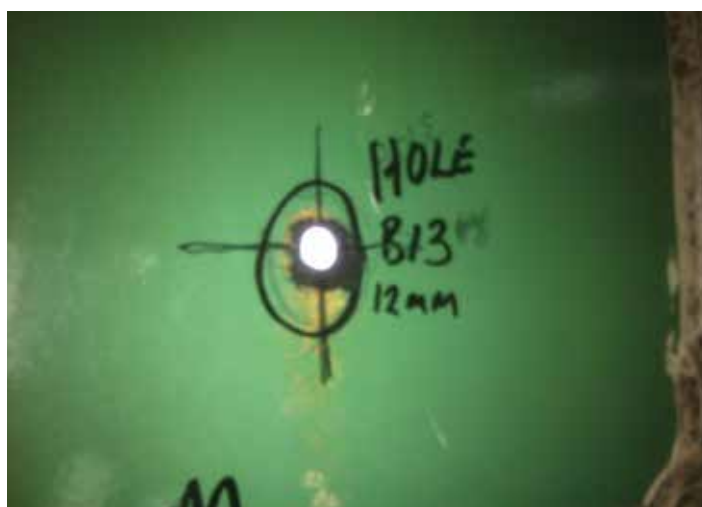
Figure 3.

The second case involved several very large effluent aeration tanks constructed for municipal refuse treatment facilities in northwest Europe. Even before formal handover, the tanks were found to be springing leaks, to the consternation of the owners and the exasperation of the environmental authority. Investigation revealed dramatic holes in the shells (Figure 3).

The facility EPC contractor interpreted the problem as defective lining, and called in lining experts. Time and money were then invested in carrying out lining repairs in the hope that this would remedy the problem. Unfortunately, it seems the lining experts had forgotten their galvanic corrosion lessons. They missed the fact that the very well-lined carbon steel tanks contained multiple bare stainless steel nozzles. As in Case 1, the cathode to anode area ratios were enormous, so the galvanic corrosion penetration was very rapid (the steel effectively undergoing electrochemical machining). Improving the quality of the lining on the carbon steel breached a cardinal rule of managing galvanic corrosion, which is to coat the cathode. All the re-lining work achieved was that the tanks developed leaks even more quickly when returned to service.

Eventually corrosion expertise was called up. The solution was straightforward: paint the stainless steel, and install a modest sacrificial anode provision. Unfortunately, however, the EPC contractor was unwilling to engage in what it regarded as the “untried” technology of CP. Facing litigation, it took the financially punishing step of demolishing the tanks and rebuilding them in polymer-lined reinforced concrete.

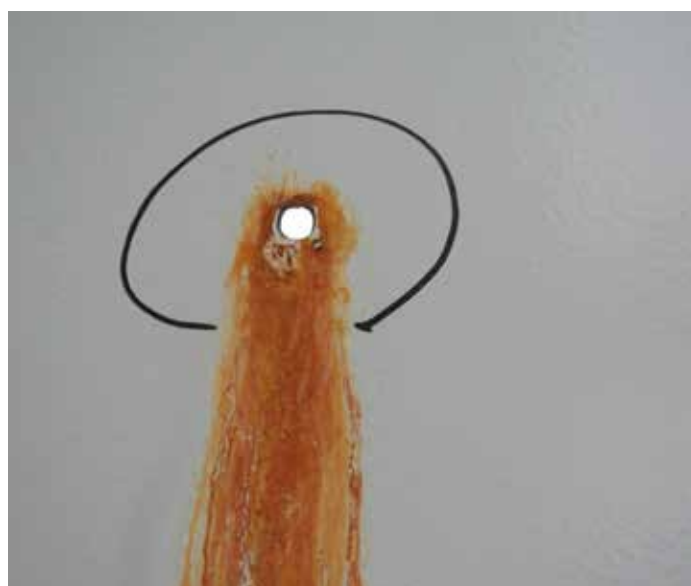
Figure 4.

In many ways, Case 3 was similar to Case 2. It involved a number of large aeration tanks for treating effluent produced by a major European beverage manufacturer. Again, the carbon steel tanks were very well lined, but they contained stainless steel inlet piping and aeration equipment. Some credit is due to the designers who recognised the potential for galvanic corrosion. They addressed it, in accordance with good engineering practice, by ensuring that the stainless steel piping and diffusers were electrically isolated from the tank (or so they thought).

Experience tells us that a corrosion engineer can always call for electrical isolation between tanks and piping. But, in practice, the electrical engineers will always be working to achieve the opposite for the purpose of electrical safety. Thus, although the piping was electrically isolated at the point of entry to the tanks, both piping and tank walls were bonded into the common site electrical earthing system. So, notwithstanding the design intent, a galvanic cell with an adverse cathode to anode area ratio was created. Inevitably, galvanic corrosion occurred and the tanks leaked (Figure 4).

Unlike the EPC contractor in Case 2, the Owner of this facility called in corrosion, rather than *lining*, expertise. The corrosion specialist advised installing CP. This was accepted by the owner, and a competent contractor was engaged to supply a simple, but effective, system of sacrificial anodes suspended from cantilevered brackets fixed to the tank rim (Figure 5).
